Manhole Inspection Summary

Manhole # S39Y1_001MH

Insp Date: **4/8/08 8:17 AM**

Location Address: **3713 5th St.**

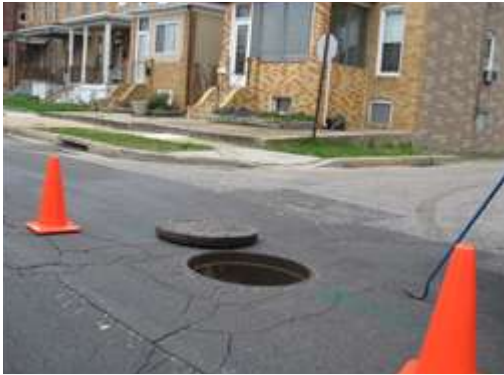
Location View

3715 5th St.

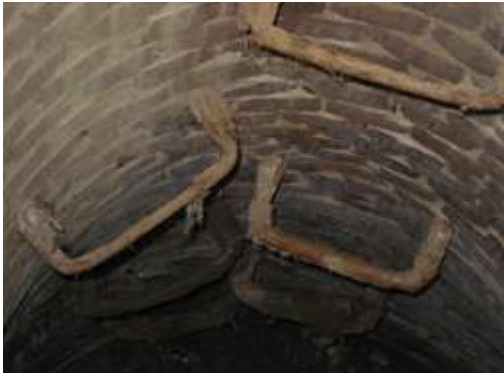
Steps Count: **6** Missing: **0** ☒ **Corroded**

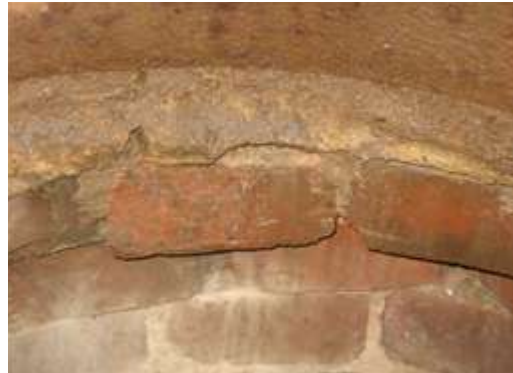
Defect 1

Frame Offset: **1** (in.) Condition: ☒ Sound ☐ Cracked ☐ Leaks

Condition: ☐ Sound ☒ **Cracked** ☐ Root Intrusion ☐ Loose Brick ☐ Deteriorated

Infiltration: ☐ None ☒ **Joint** ☒ **Cracks** ☐ Mortar ☐ Roots ☐ Wall

Frame Offset and Crack at Joint

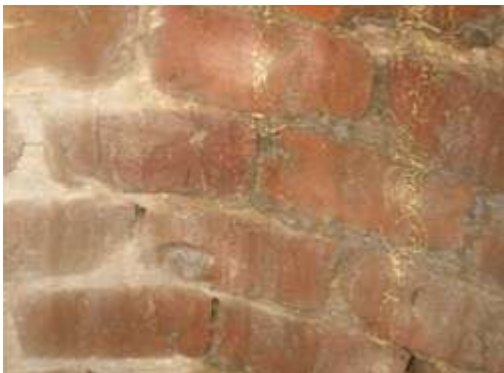
Defect 2

Condition: ☐ Sound ☒ **Cracked** ☐ Root Intrusion ☐ Loose Brick ☐ Deteriorated

Infiltration: ☐ None ☐ Joint ☒ **Cracks** ☐ Mortar ☐ Roots ☒ **Wall**

Crack and Infiltration on wall

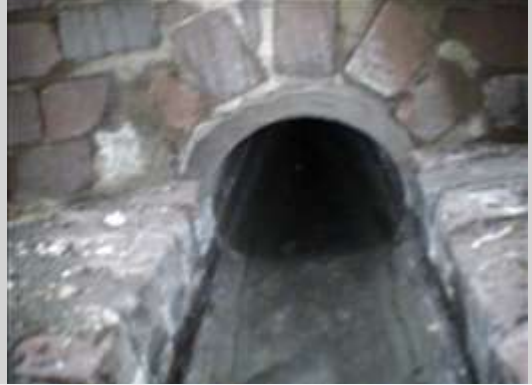
12 O'Clock Outflow

8 in. Circular Gravity Sewer
Pipe Out @ 12 O'Clock

Pipe Height: **8.4** (in.) Rod and Bar (Angled)
Pipe Material: **DIP/CI** ☐ Pipe Lined
Invert Depth: **11.25** (ft.) Flow Characteristics: **Slow**
Deposits: ☒ None ☐ Mud ☐ Sludge ☐ Debris ☐ Grease
Silt Depth: (in.) Deposits Extent:
Infiltration: **None** Pipe Seal Cond: **Sound**

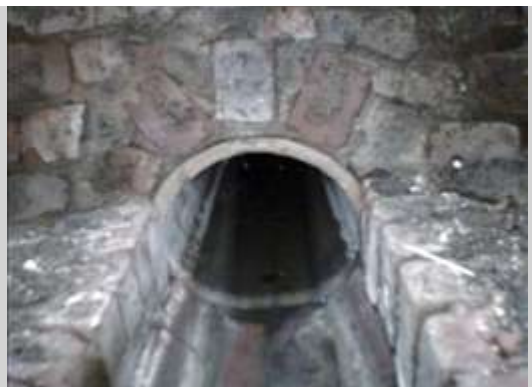
6 O'Clock Inflow

8 in. Circular Gravity Sewer
Pipe In @ 6 O'Clock

Pipe Height: **8.4** (in.) Rod and Bar (Angled)
Pipe Material: **Clay** ☐ Pipe Lined
Invert Depth: **11.20** (ft.) Flow Characteristics: **Slow**
Deposits: ☒ None ☐ Mud ☐ Sludge ☐ Debris ☐ Grease
Silt Depth: (in.) Deposits Extent:
Infiltration: **None** Pipe Seal Cond: **Unknown**
